# **Preliminary Structural Evaluation and Presentation of Refurbishment Options for the Usher Mill in Erving, MA**

Report - August 2003

**Building Materials and Wood Technology**  
University of Massachusetts, Amherst, MA

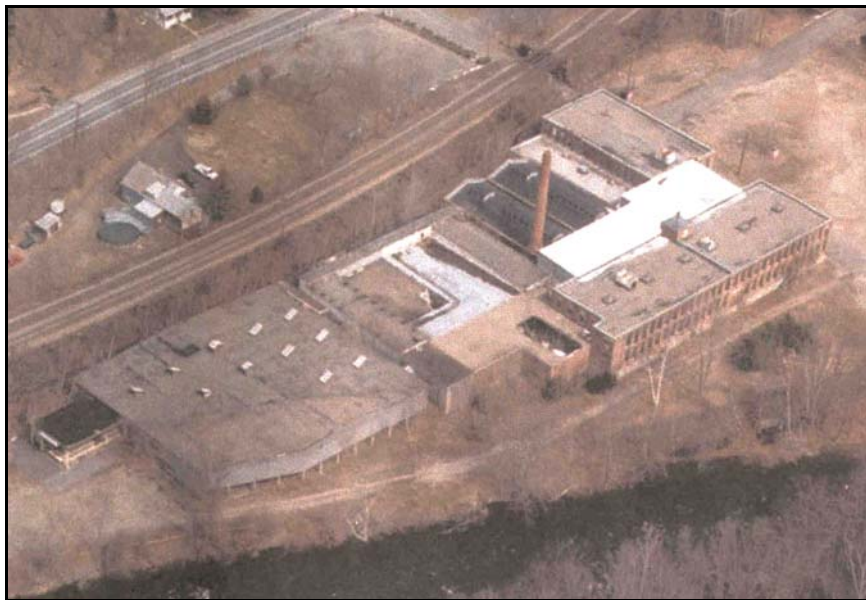
Damages in this building derive mainly from water intrusion through the roof and the windows. As can be identified in Figure 12 by standing water on the roof, drainage of the minimally sloped roof is insufficient (and very likely has been for some time). In addition, almost all exterior windows have been vandalized and provide no protection against the elements. As a result, water damages are mainly located at the eastern or western exterior walls of this building.

Similar to building 1, roof damage can be identified by areas of standing water on the aerial overview picture (Figure 12). As a result, roof damage is mostly located at the eaves (northern and southern outside walls). Consequently, most rot and mold in roof-level wood members was observed at these locations as well (see Figure 15). Wooden beams and decking closer to the apex of the roof are mostly in good condition.

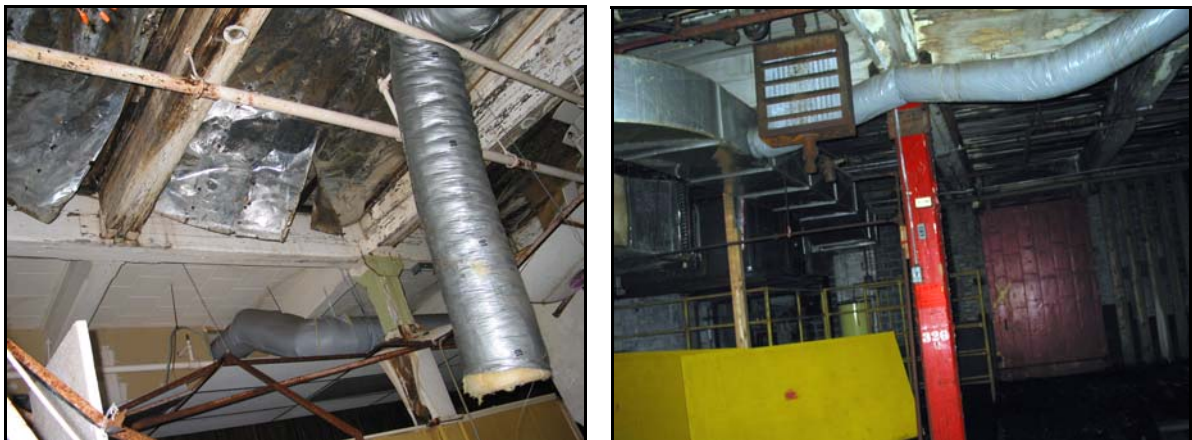
Typical structural damage to the wood beams, rafters and headers (and to a lesser extent to the columns) consists of rotting and the formation of mold as can be seen in Figure 13. This is in the less drastic cases limited to only the upper portion of the members and is located very frequently near the eaves. In more severe cases, this involves the entire members (top and bottom) and can extend over their full length. The latter is more frequently the case for floor beams in the lower stories since water had been able to spread over a larger floor area by the time it reaches them.

At the roof level, it was found that 41% of all wooden members showed visible damages (partial or full). Since the second and first floor levels could not fully be accessed, it can only be speculated that damage would be in approximately 40-50% of all second floor and more than 50% of all first floor members (judging from the condition of the first floor beams in building 2). Columns (where accessible) appear for the most part to be in good condition, although it can be expected that elevated moisture content levels at their bases (where they sit on horizontal beams in very moist environments due to water accumulation) made them prone to fungal growth as well. Due to floor coverings, these areas could not be investigated further.

**Figure 13 - Building 1: Mold Damaged Beams on 2<sup>nd</sup> and 1<sup>st</sup> Floor**

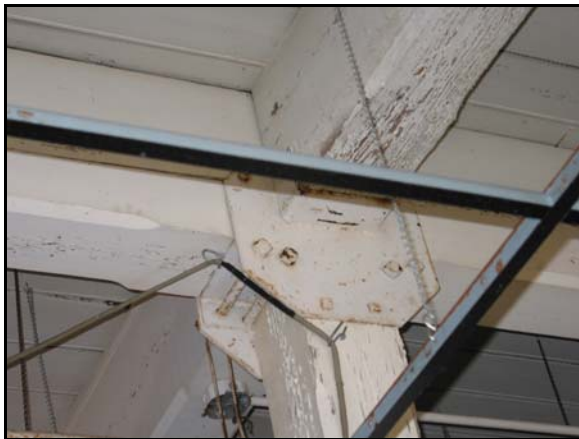
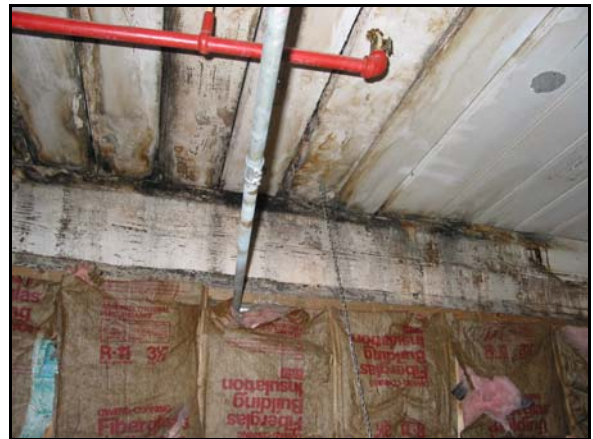
Structural damage to the wood members in this building is similar to building 1 and consists of rot and mold formation (see Figure 14, Figure 15 and Figure 16) and subsequent deterioration (in part or in full). Although most inside members (beams, headers and columns) are dry and appear to be sound at the roof level (Figure 14), water distributing through the structure (as described before) also affected similarly located second floor members. Finally, all first floor beams (and the decking) are severely damaged by mold (see Figure 16).

**Figure 14 - Building 2: Sound Beam Intersection above Column;  
Deteriorated top of Beam at Wall**

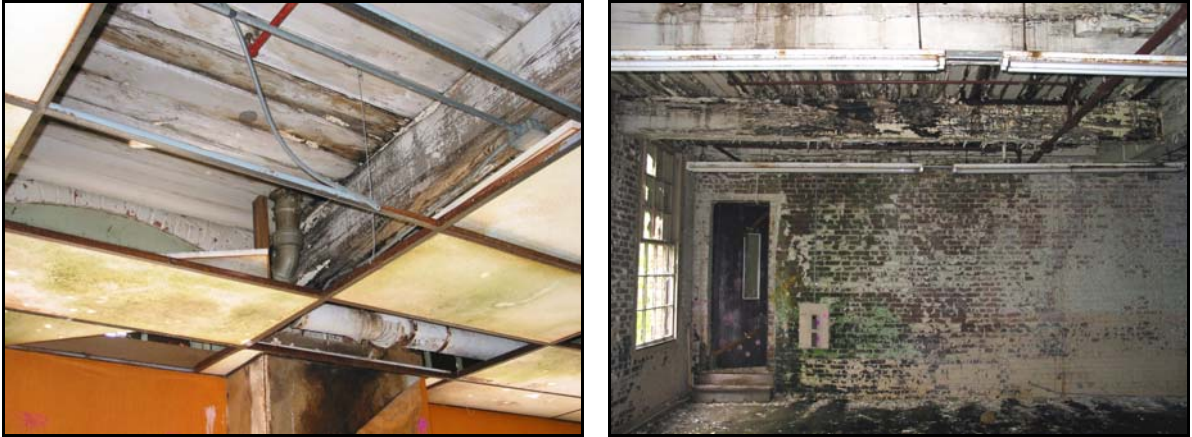
Resulting from this, the level of damaged wooden members increases sharply from the roof to the first floor (39% at the roof, 47% on the second floor and an estimated 80-100% on the first floor). An area that exhibits a large number of deteriorated structural members is located in the south-western corner of this building (one of the second floor beams is severely deflecting).

**Figure 15 - Building 2: Deterioration at Roof Drain;  
Sagging Molded Beam in SW Corner**

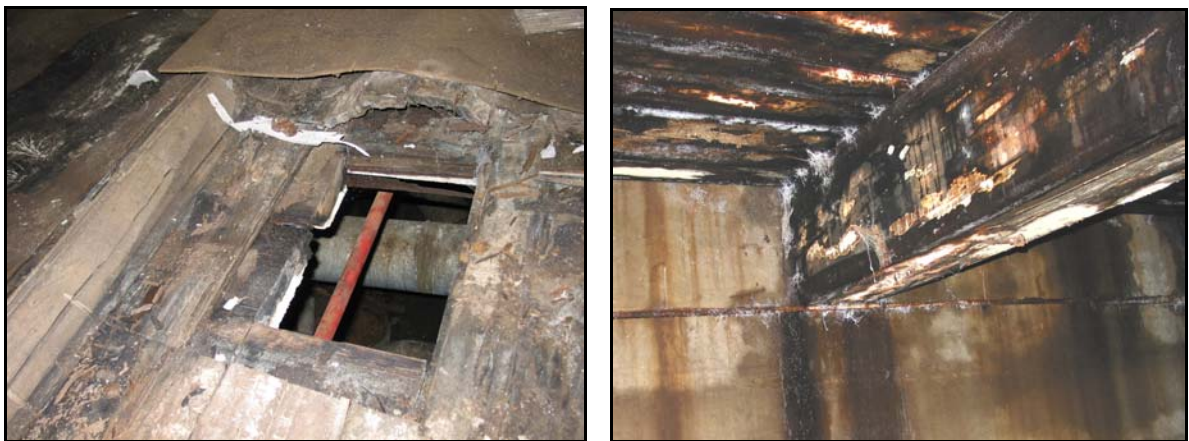
Due to the moisture transported through the structure, the interior side of the basement concrete wall is damp (Figure 16). In addition, the outside of this wall showed some vertical cracks at the floor beam locations in the south-eastern corner of the building. Since this area could not be viewed from the inside it is only speculated that the cracks might be due to moisture expansion of the floor beams.

**Figure 16 - Building 2: - 1<sup>st</sup> Floor Decking Deterioration;  
Mold on 1<sup>st</sup> Floor Beams, Moisture in Concrete Basement Wall**

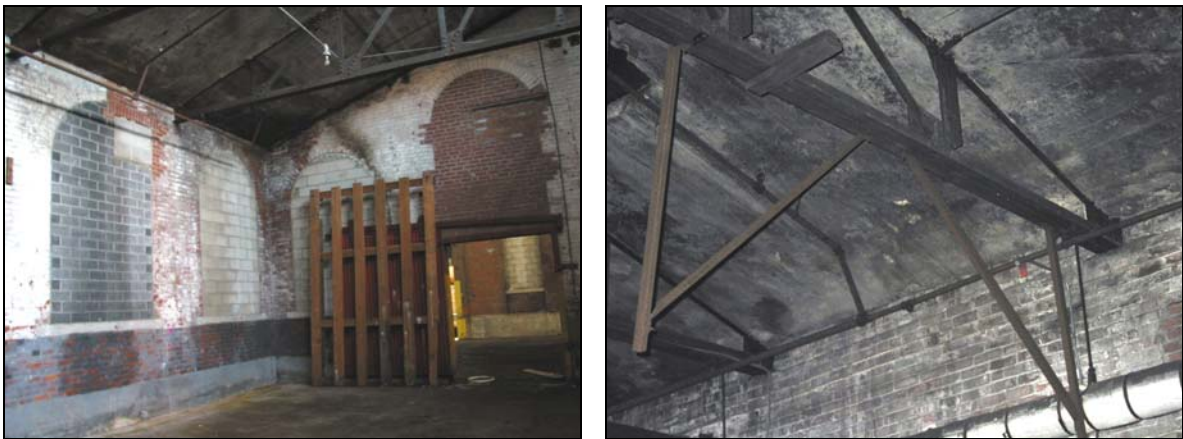
This building – which has no wooden structural members – appears to have had only very little water intrusion (see Figure 17). This may have been due to a larger roof slope (compared to buildings 1 and 2). Any water that has entered the walls is very likely caused by drainage problems of the adjacent roofs (or ponding between roof slopes).

**Figure 17 - Building 3: Various Masonry Types; Truss Bearings**

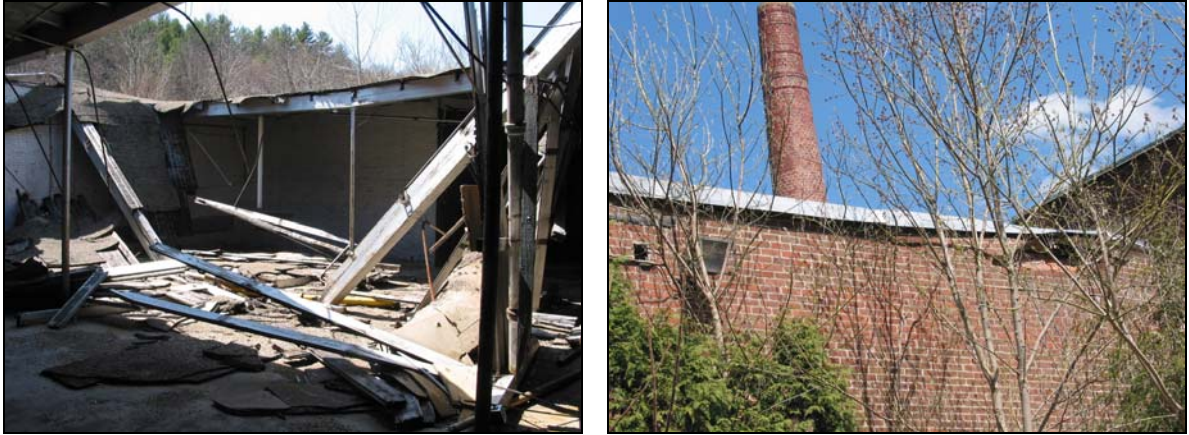
The condition of this building was just superficially assessed. Main structural problems are two roof failures (south and north-center of the building), where entire sections of the roof, together with beams and decking, have collapsed. Although some adjacent beams and columns appeared to be in their original configurations, some additional columns were found to have buckled. This might have been initially due to accident-based deformations, but very likely has increased under heavy snow loads. Future additional roof collapses are likely.

The masonry walls lining the kilns appear to be in a weathered condition deriving from their initial use and additional water damage due to the collapsed roofs. The walls enclosing the southern portion of building 4 have sustained some damage at their top which derived from the roof collapse (see Figure 18).

**Figure 18 - Building 4: Roof Collapse; Damaged Masonry Wall**

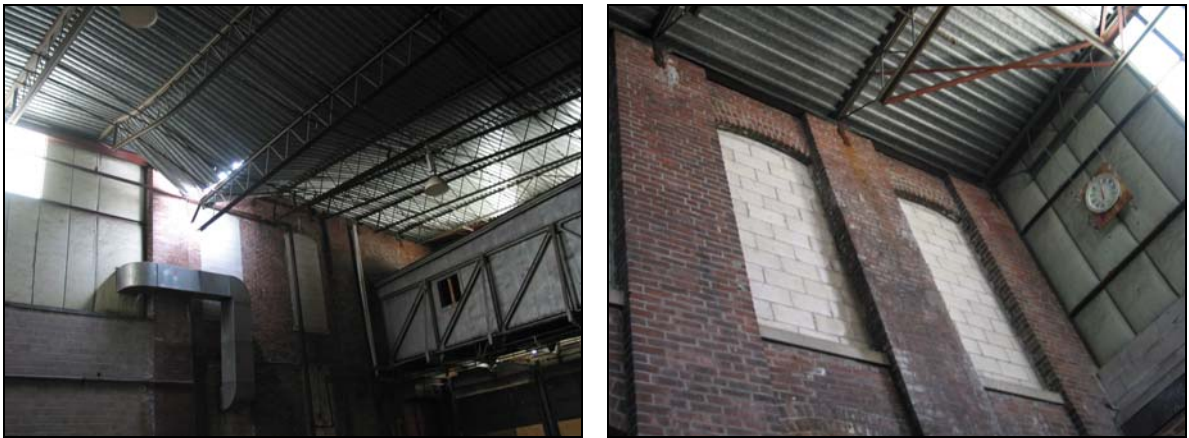
As can be observed at the wall bearings of some of the open-web steel trusses, water intrusion has led to the formation of rust (see Figure 19, right). This in turn led to the deterioration of some trusses at that crucial location which subsequently allowed the failure and collapse of some of these trusses at the eastern end of the building (over the loading dock). It is thus very likely that more roof collapses will occur since other trusses are rusting as well. In addition, deflected trusses near the roof collapse will accumulate snow and are very likely to fail under these conditions.

**Figure 19 - Building 5: Partial Roof Collapse; Water Damage**

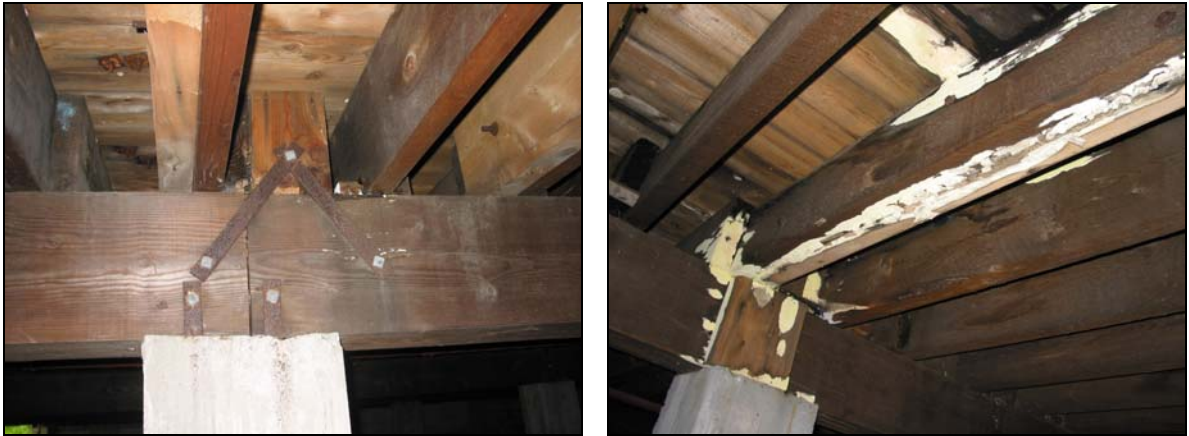
Water entering the buildings at these points led to severe but quite localized damages (as can be seen in Figure 20, right). These damages typically extend to both the roof as well as the floor structure and may also be present in the column.

**Figure 20 - Building 6: Intact Floor System (Note: Eccentricity of Column); Mold Damaged Floor Beams and Joists**
